Manhole Inspection Summary

Manhole # S11EE2017MH

Insp Date: **8/2/06 10:27 AM**

Location Address: **2222 CREST RD**

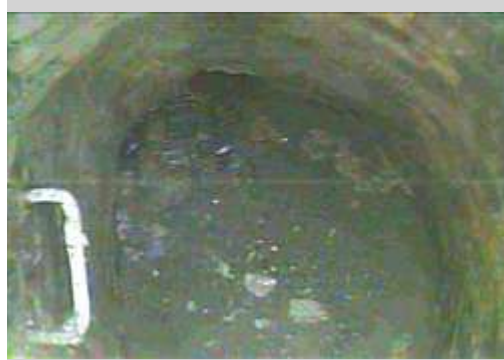
Top View

☒ **Debris**

Channel debris.

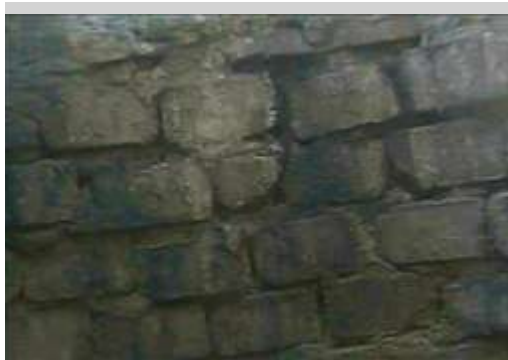
Defect

Corbel infiltration.

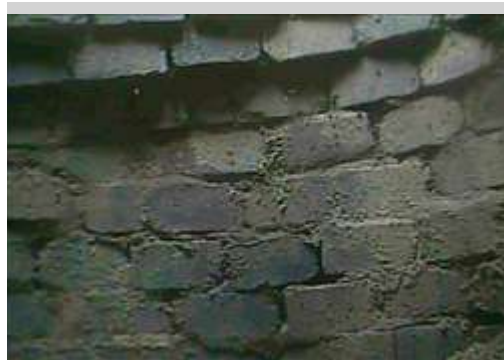
Defect

Corbel and Barrel infiltration.

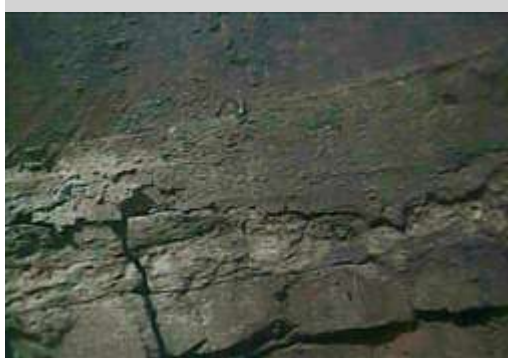
Defect

Frame leaks. Adjustment deterioration, cracks, and infiltration.

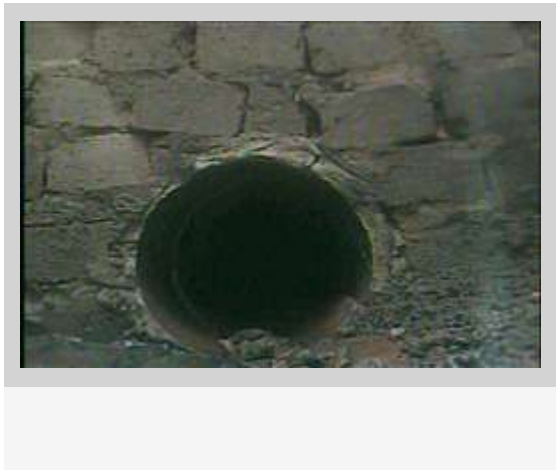
8 in. Circular Gravity Sewer
Pipe Out @ 12 O'Clock

Infiltration: **Evidence** Pipe Seal Cond: **Cracked**
